EL TORO Restaurant - Clute, TX.

Energy Efficiency Case Study Summary

El Toro – Clute Energy Efficiency Trial

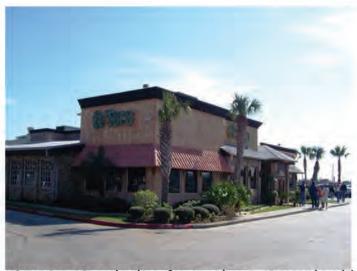
Equipment Selected for Data Trial - 15 ton High Efficiency American Standard rooftop package - 3 months old

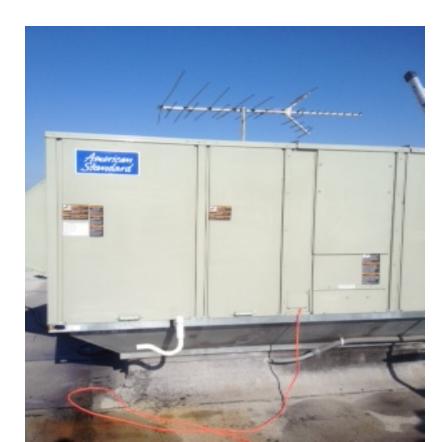
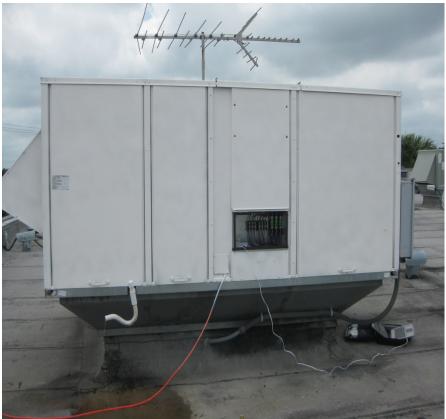
Before After

- A KWH data logger was placed on the unit 2 weeks prior to starting the project.
- At the 2 week point, the unit condenser coil and cabinet were cleaned.
- The condenser coil was coated with MicroGuard AD 35 siloxane coating to prevent corrosion and enhance energy efficiency.
- The exterior cabinet was coated with an Energy Star Ceramic coating to protect against corrosion and to provide a radiant barrier against solar heat gain, which reduces load and energy consumption. Exterior cabinet temperature was reduced from 135*F to 92*F.
- KWH data logger continued to collect data for 2 weeks after.

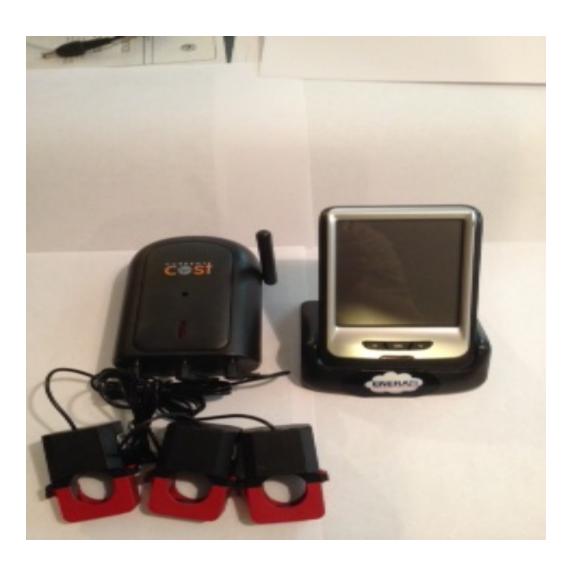
Data Logging Equipment

(Records KWH energy usage)

- Placed KWH data loggers and recorded KWH consumption for two weeks
- Cleaned and coated condenser coils with MicroGuard AD 35, coated cabinet with ThermaCote energy star ceramic coating
 - · Continued to record KWH consumption for an additional two weeks
- Collected data at the 4 week mark and compared like degree days
