# ThermaCote Case Studies

CONSTRUCTION, INDUSTRIAL AND SPECIALITY

## SPRAY-APPLIED THERMAL BARRIER

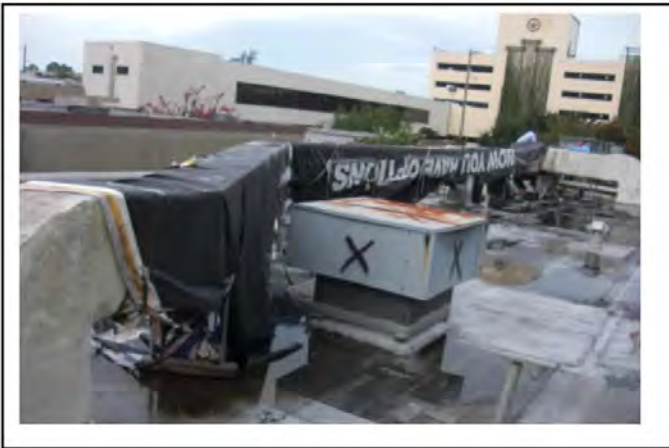
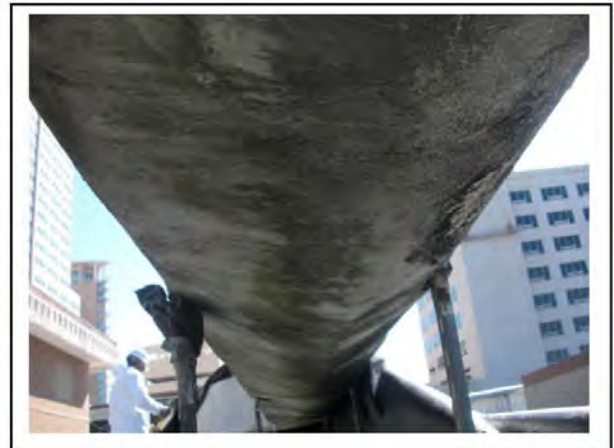
**Duct prior to work**

- Duct insulation was falling off as result of condensation moisture saturation
- Portions of the duct were rusting from the moisture saturation
- Several leaks were found in duct line
- AHU internally was in need of cleaning

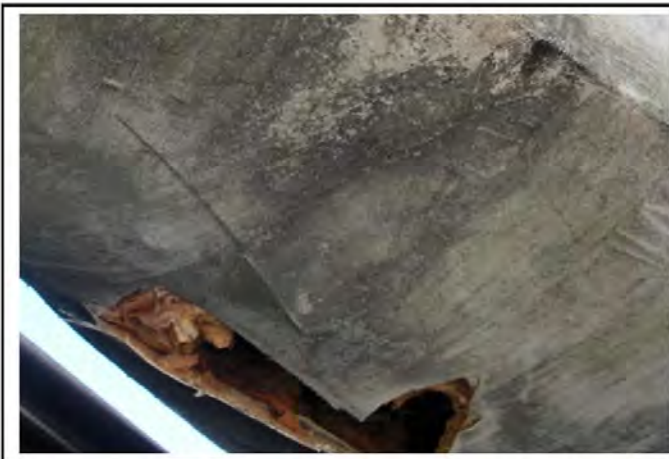
**Bottom of duct has insulation that is bellied out with water**

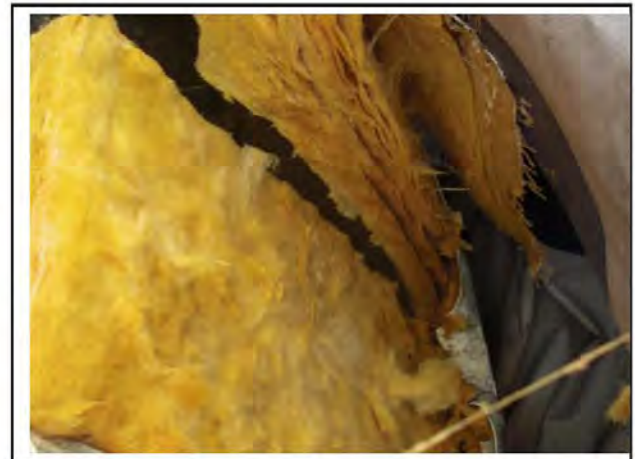
**Moisture has broken through seal layer**

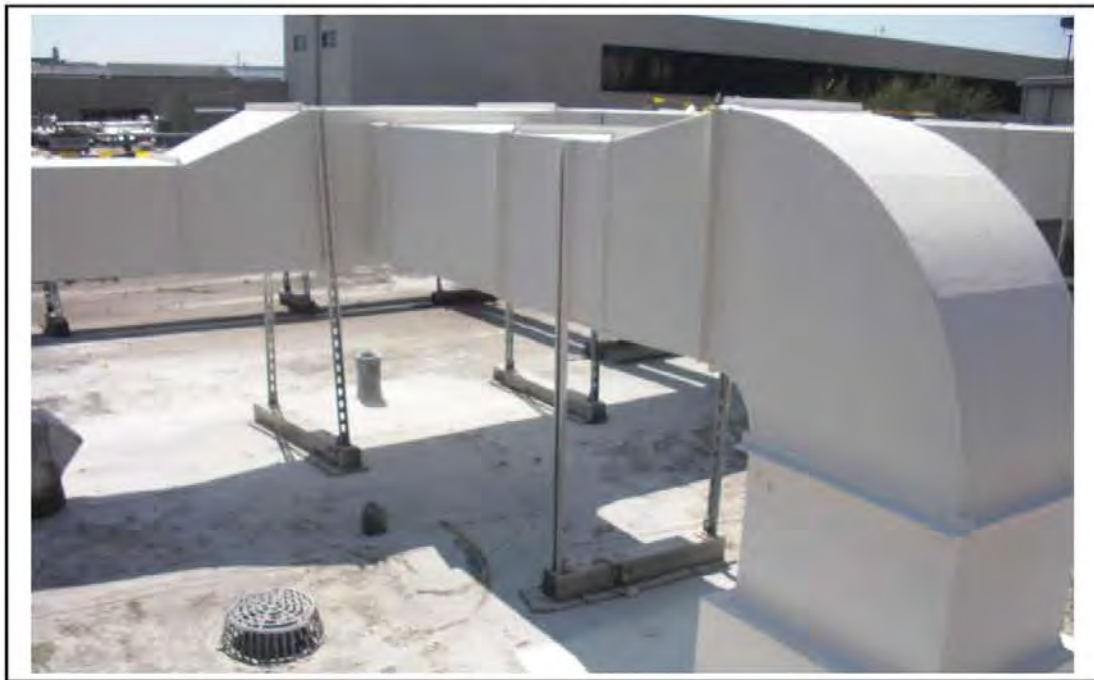
### ThermaCote® Applied

**Eliminates condensation and stops corrosion**

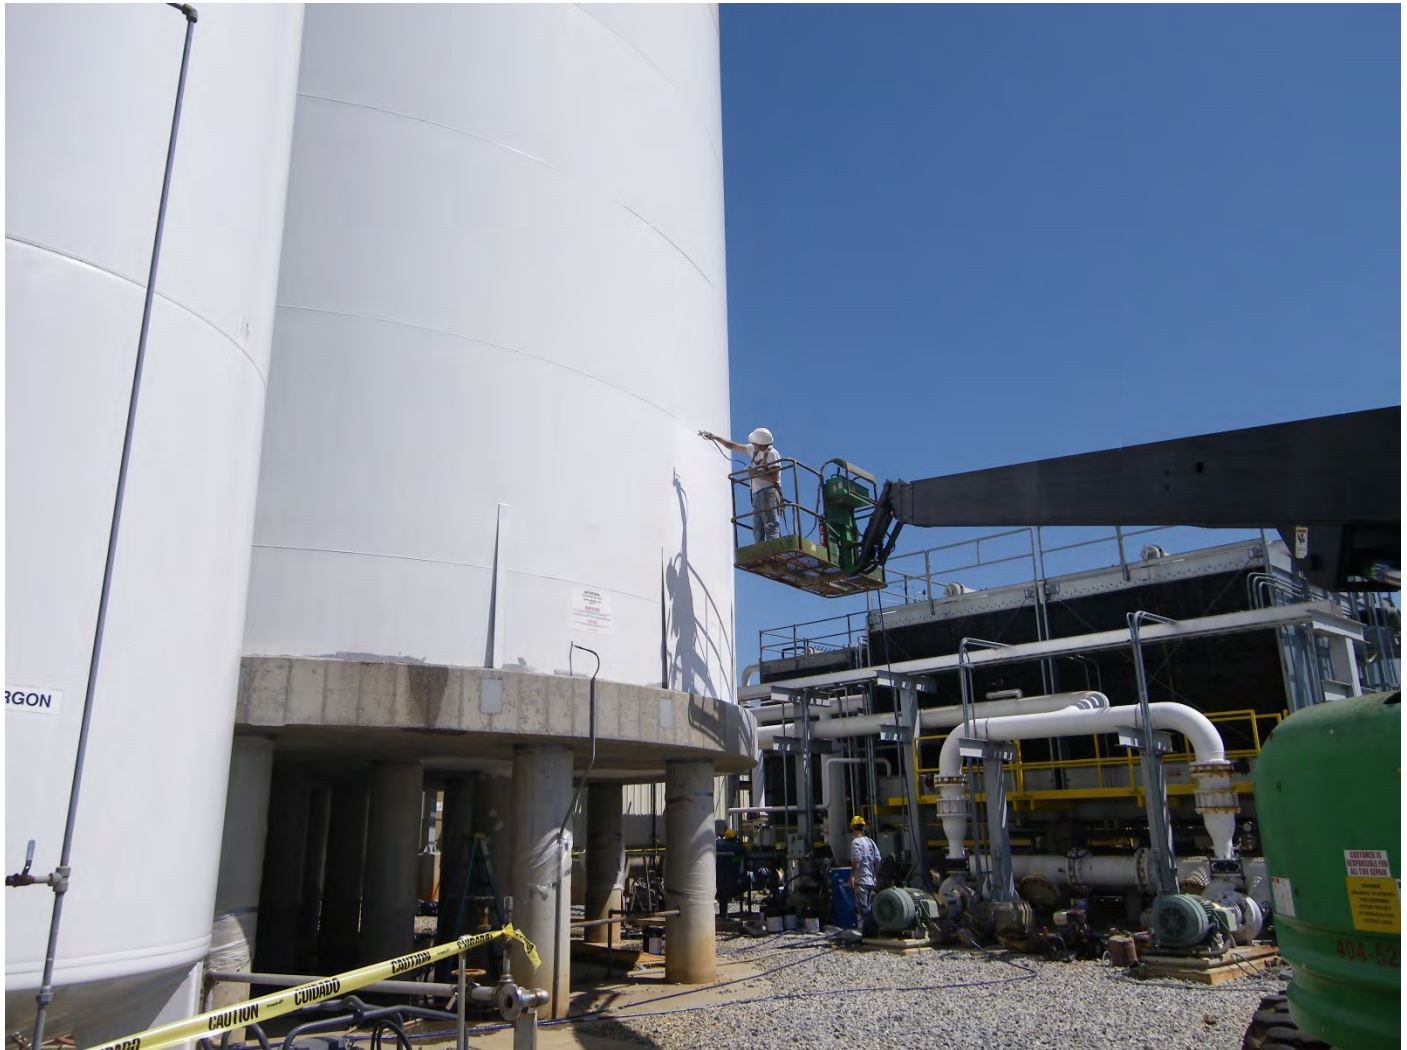
The application 'specs' are 2mm of ThermaCote® after prep. An alkyd enamel 'red metal' primer was used where blasting was required to remove corrosion.

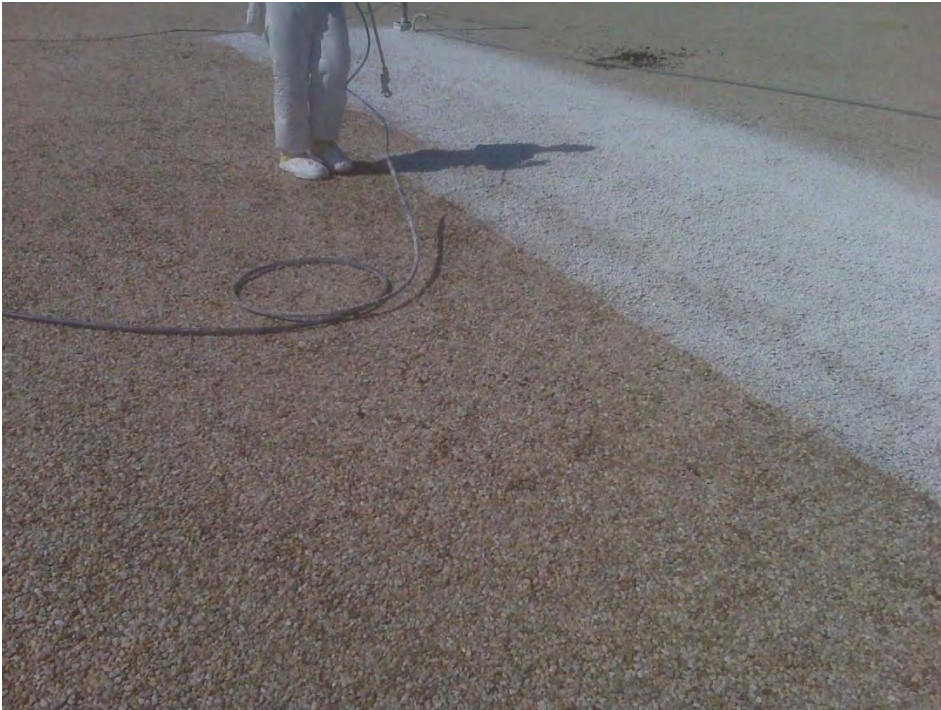
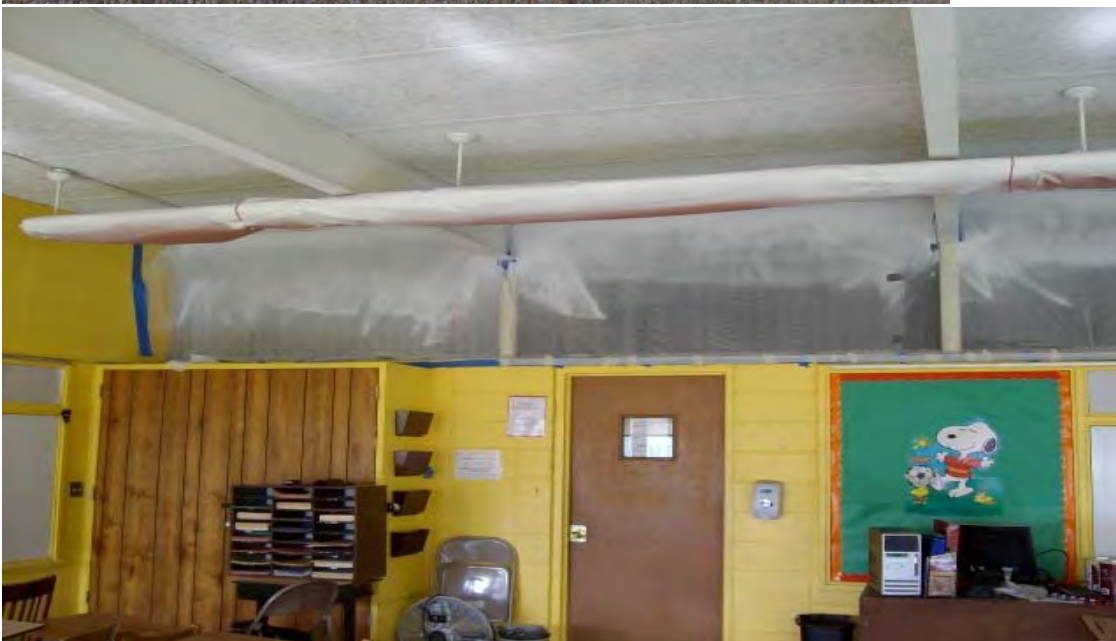
Energy consumption compare between two rooms, Classroom #12 was chosen to be coated with the product with the adjacent classroom #11 assigned as the control comparison. The test rooms are of identical size with the exact same amount of exterior glass, all of which faces west. In addition these rooms are cooled by matched 2 ½ ton Bard wall mount air conditioners. These units are of the same model number and have nearly sequential serial numbers indicating that they were manufactured within days or hours of each other.

Meter readings were recorded on three separate occasions in both classrooms. Power usage in the last period of approx. 22.5 hours revealed a 40% KWH usage reduction in the coated room. Latest readings show the ThermaCote classroom at 129 KWH, and the uncoated classroom at 202 KWH. This calculates into a 36.1% reduction in electricity usage for the air conditioner in the coated room as opposed to the usage in the control room. It bears noting that this facility already had a light colored roof coating. Application of this material to dark roofs or the underside of roof decking with dark shingles would produce even more dramatic results. In addition, ThermaCote has a .83 solar reflectivity as established by the Cool Roof Rating Counsel. This high radiant reflectance can result in reduction in the number of fluorescent tubes needed to deliver an appropriate amount of light to the desktops, which could conceivably increase savings on the lighting portion of the power bill.

This calculates into a 36.1% reduction in electricity usage for the air conditioner in the coated room as opposed to the usage in the control room. It bears noting that this facility already had a light colored roof coating, (see fig. 3). Application of this material to dark roofs or the underside of roof decking with dark shingles may produce even more dramatic results. In addition, this product has a .83 solar reflectivity as established by the Cool Roof Rating Counsel. This high radiant reflectance may result in reduction in the number of fluorescent tubes needed to deliver an appropriate amount of light to the desktops. This could conceivably result in increased savings on the lighting portion of the bill.

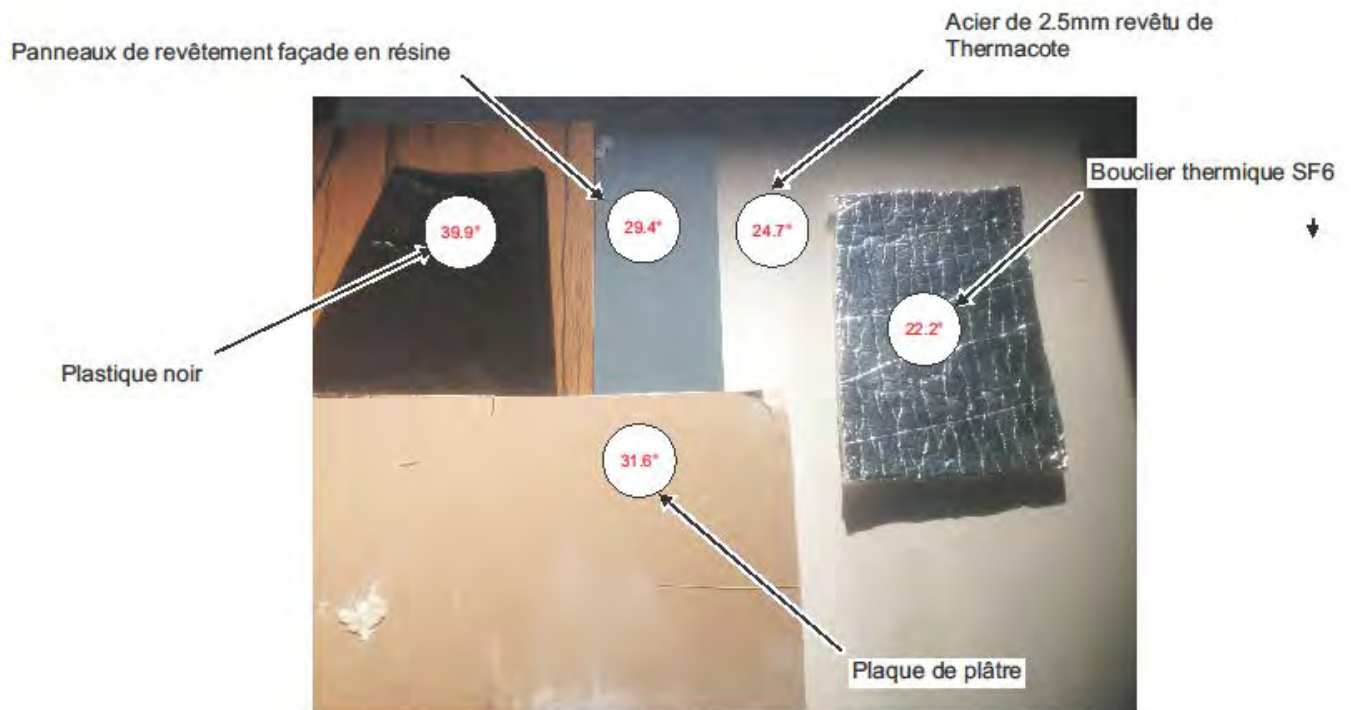
- Plastique Noir / Black plastic= 39.9°C
- Plaque de plâtre / Plasterboard= 31.6°C
- Panneaux de revêtement de façade en résine / Plastic panels for facade =29.4°C
- Acier de 2.5mm revêtu de ThermaCote (0.5mm) / Metal sheet 2.5mm coated with ThermaCote= 24.7°C
- Isolant mince de 8mm / Thin insulation 8mm = 22.2°C

**Matériaux exposés en plein soleil à Carcassonne le 5 février à 14h30  
temps d'exposition 1 heure**

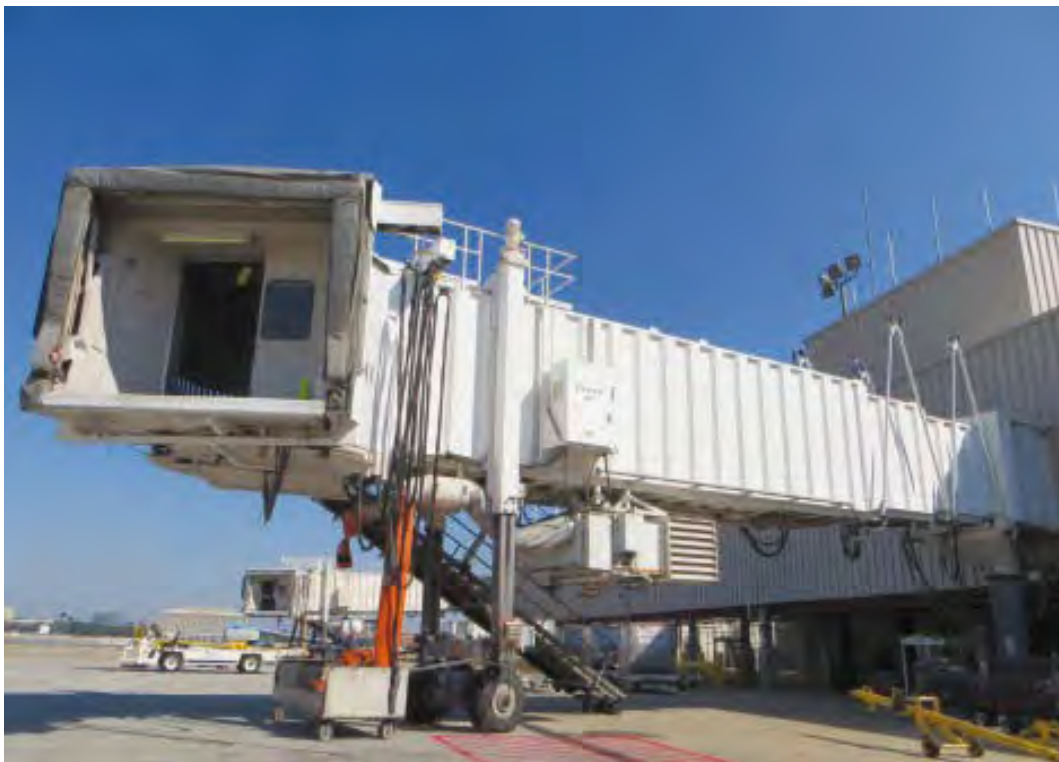
ThermaCote in reducing the heat load on passengers boarding bridges which was conducted at Hartsfield-Jackson Atlanta Airport from July 12 to August 15 2013. Passenger boarding bridges, air bridges, skyways and jet ways are not directly air conditioned. During boarding and disembarking, air is exchanged between both the aircraft and the bridge, and conditioning the air in the bridges is inefficient and uncomfortable. ThermaCote was applied to the boarding bridge, reducing heat gain, lowering interior temperature, and providing energy savings.

- Temperatures in the bridge coated with ThermaCote was consistently at least 2-3°F (~1.5°C) lower than in the uncoated bridge. The temperature difference appears around 10am and lasts through the night.
- The coated bridge was cooler at arrival, and continued to get cooler until departure. The coated bridge was consistently closer to human comfort levels.
- The coating appeared to reduced heat gain by an average of 69.5 btu/h (0.02 kW).
- The energy savings from the coated bridge were ~450 BTUs (.13kWh) a day. Those savings are split between the concourse and the preconditioned air handlers attached to the bridge.
- Since the product works in part by reflecting solar radiation, the savings do not necessarily apply to cold weather.

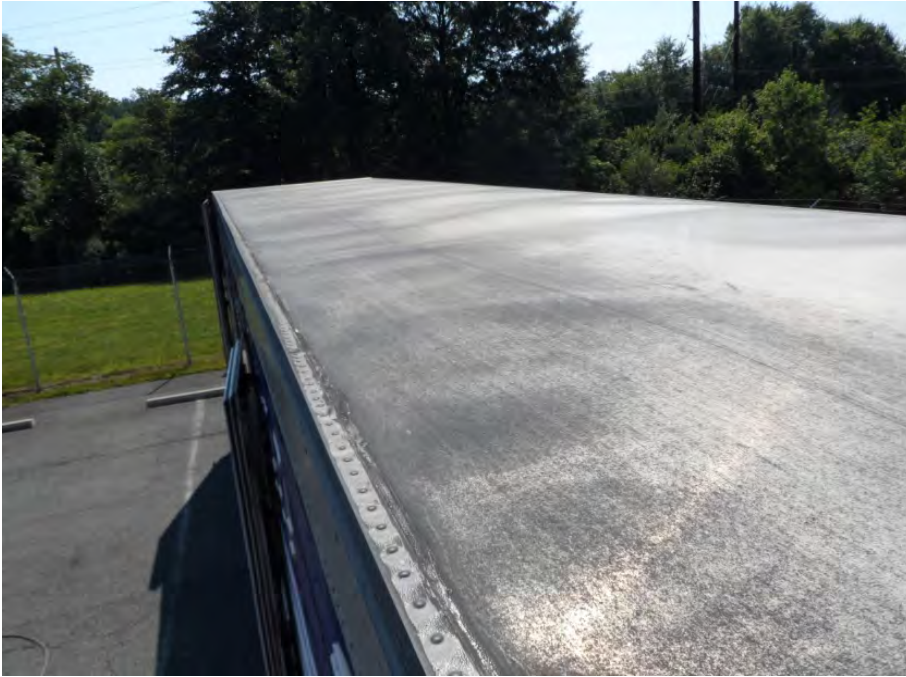
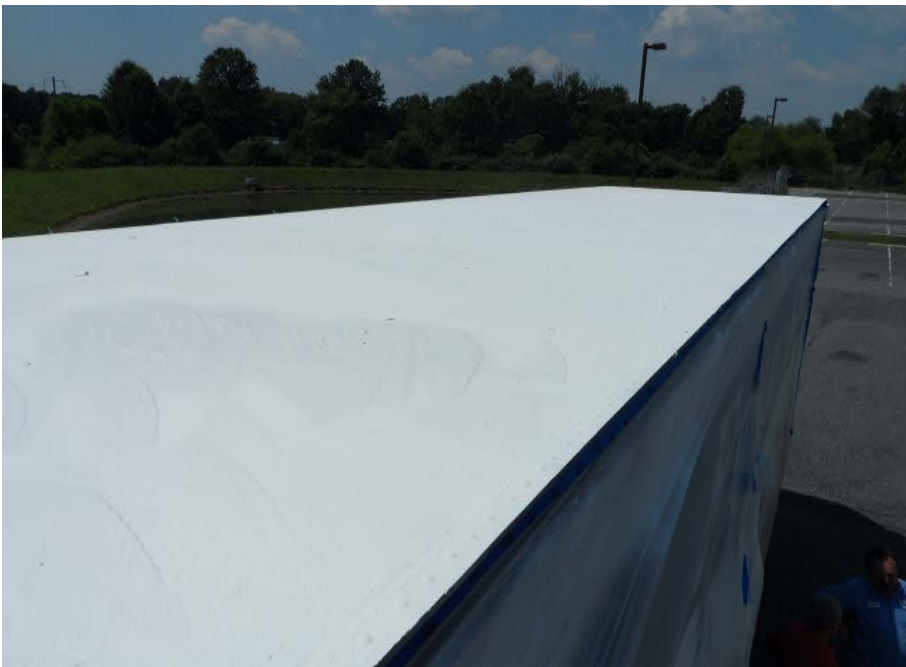
The coated trailer reached zero degrees 26% faster than the uncoated trailer.

The coated trailer used 41% less fuel for the entire test.
