**THERMA-COTE BRAND CERAMIC INSULATIVE COATING
ENERGY USAGE TEST
FINAL REPORT**

LYEFFION ELEMENTARY SCHOOL

Al. Hwy 83
Evergreen, Alabama 36401

JULY 5, 2009 – July 18, 2009

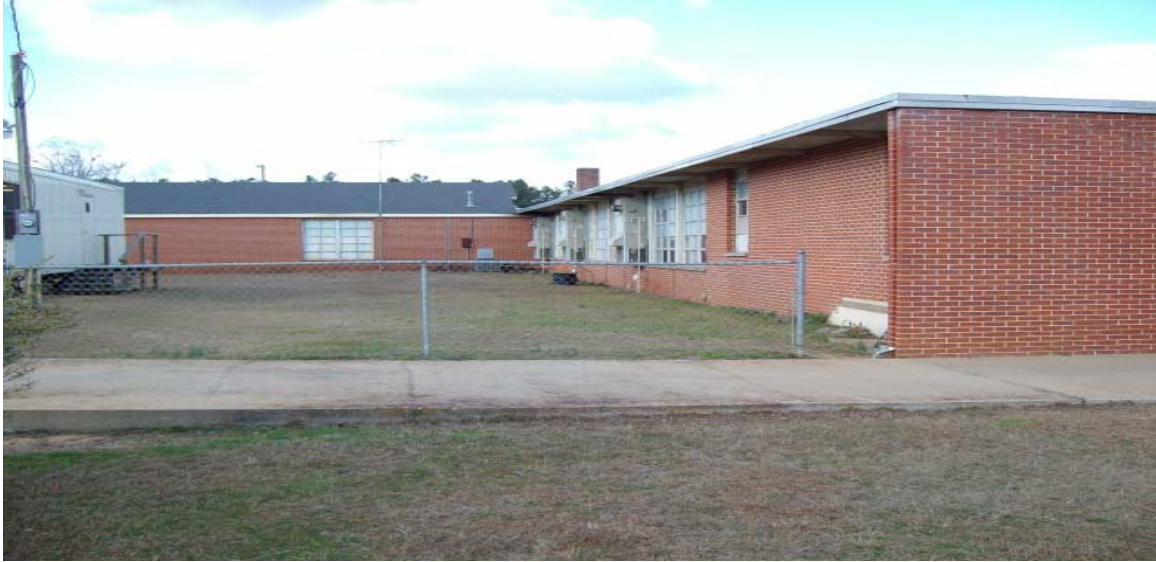
Figure 2: WEST SIDE NORTH END OF FACILITY. CLASSROOMS TESTED ARE TWO NEAREST IN PHOTO, 12 BEING THE NEAREST.

Classroom #12 was chosen to be coated with the product with the adjacent classroom #11 assigned as the control comparison. After room preparation, ceiling and upper 3 rows of frosted glass were coated with 20 gallons of product while the roof was coated with 15 gallons. Jalousie windows at top of common walls with hall were sealed off with sheet plastic to minimize infiltration from the hallway. Per manufacturer recommendations, material was allowed to cure for two weeks before monitoring began. In the interim, meter bases were installed and wired in between the service disconnects and the line voltage lugs on the air conditioners. On July 5, 2009, thermostats were set at 80 degrees, the meters were plugged in and the doors to the classrooms were pulled to and locked as were the entry doors to the building. Routine walkthroughs were performed to insure no tampering had taken place. Photos of the building exterior the interior of the rooms and the meter readings are attached.

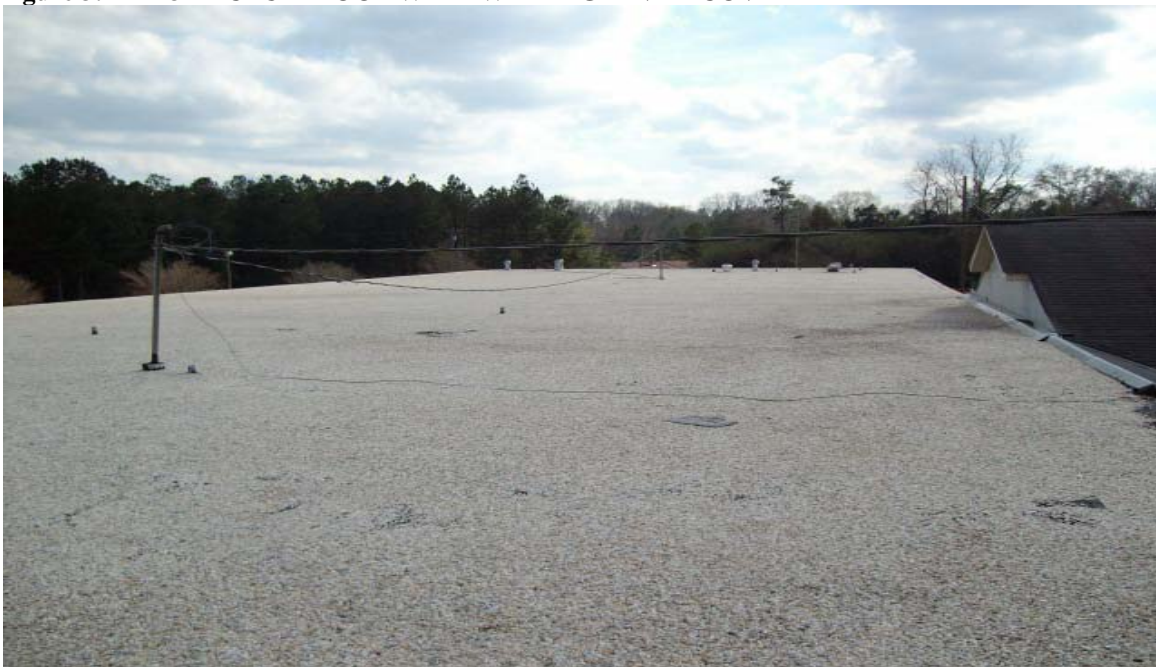
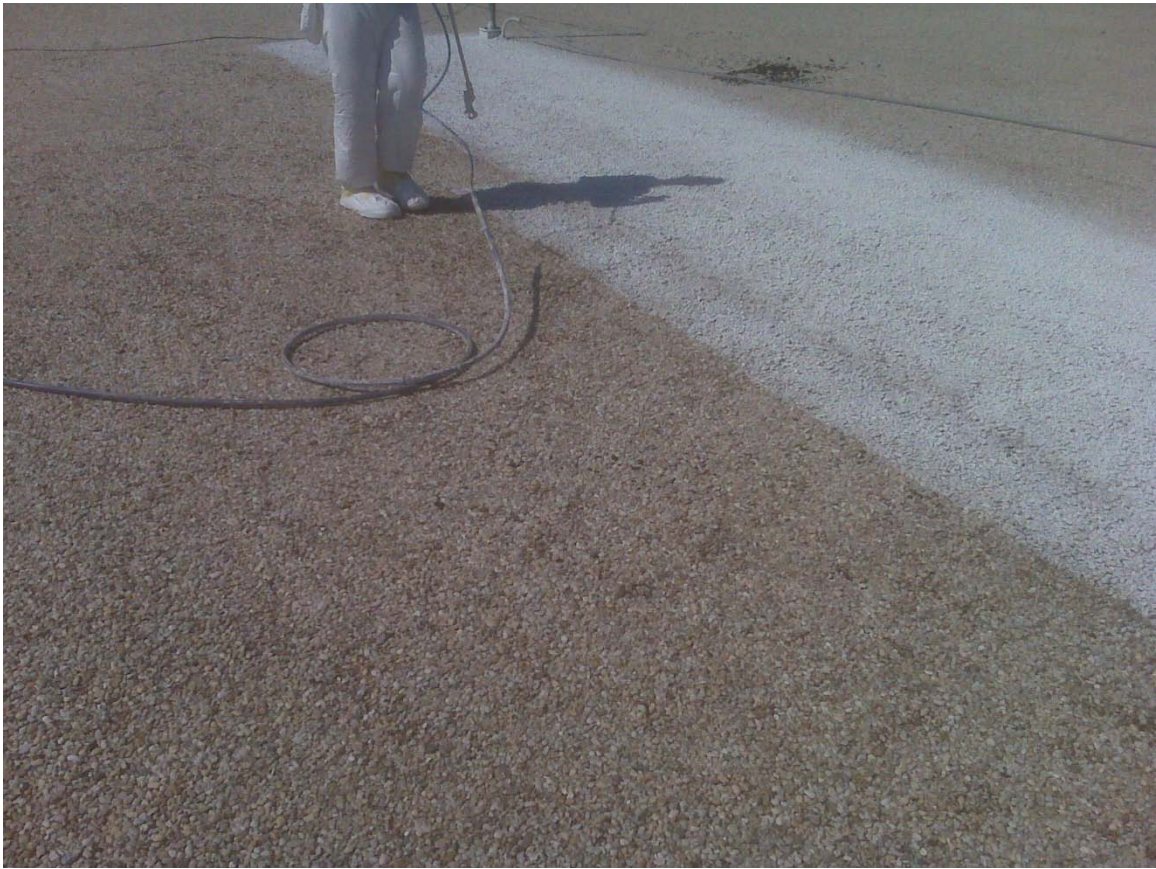
Figure 3: 2" R3 TECTUM ROOF WITH WHITE GRAVEL COVER

This calculates into a 36.1% reduction in electricity usage for the air conditioner in the coated room as opposed to the usage in the control room. It bears noting that this facility already had a light colored roof coating, (see fig. 3). Application of this material to dark roofs or the underside of roof decking with dark shingles may produce even more dramatic results. In addition, this product has a .83 solar reflectivity as established by the Cool Roof Rating Counsel. This high radiant reflectance may result in reduction in the number of fluorescent tubes needed to deliver an appropriate amount of light to the desktops. This could conceivably result in increased savings on the lighting portion of the bill.

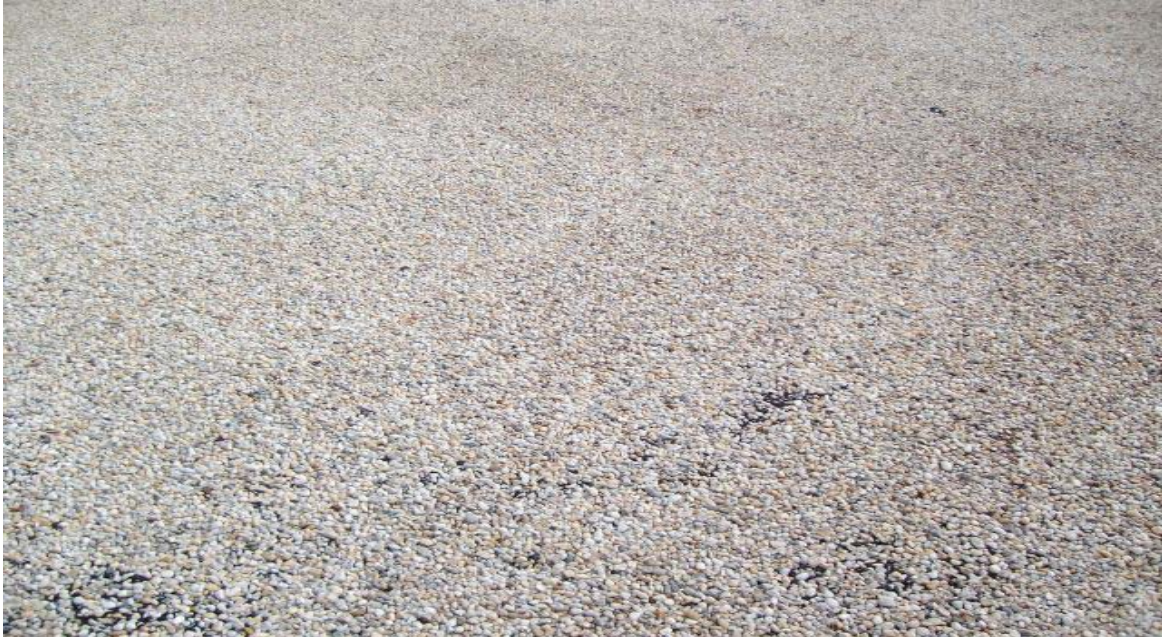
Figure 4: CLOSE-UP OF ROOF COVERING

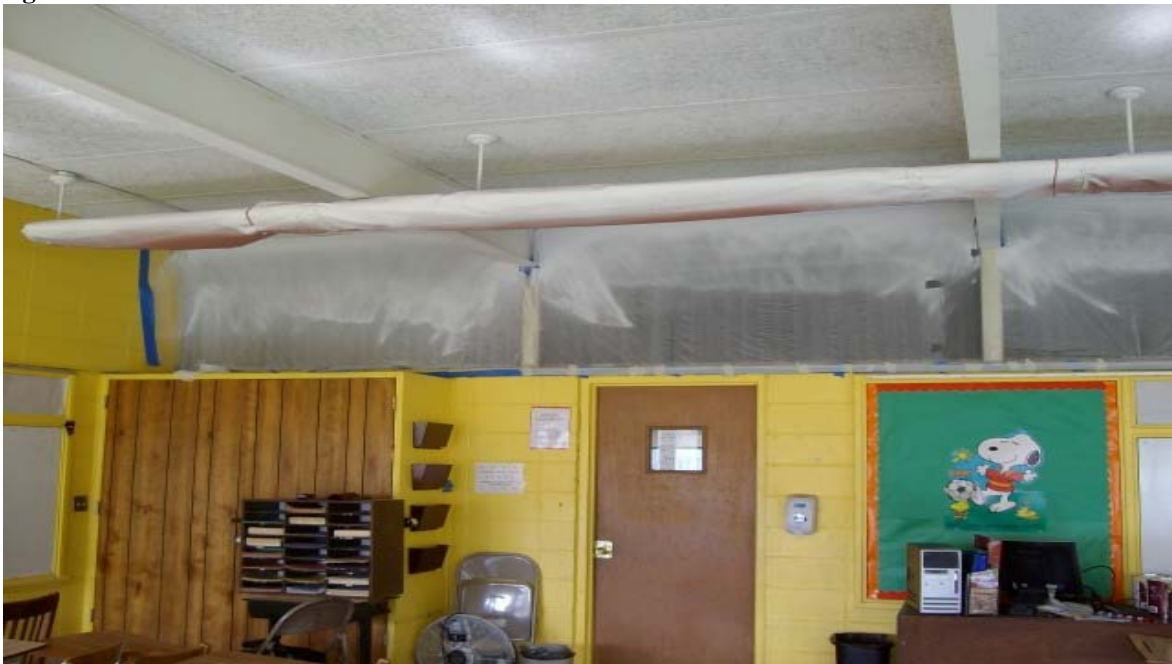
Figure 5 COATED CLASSROOM CEILING

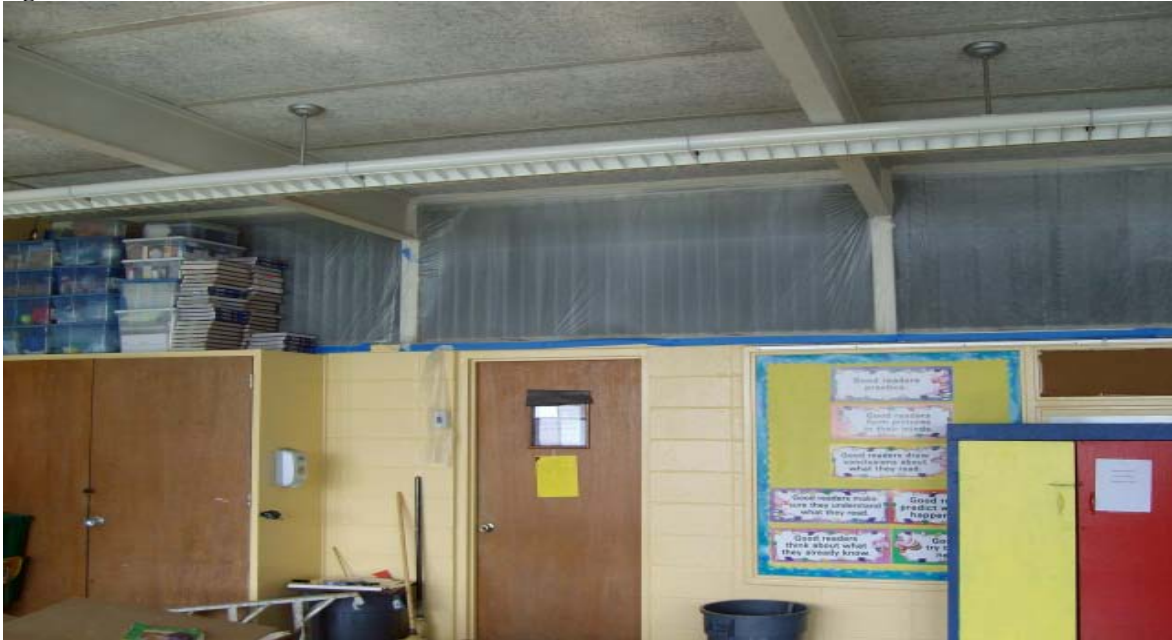
Figure 6: CONTROL CLASSROOM CEILING

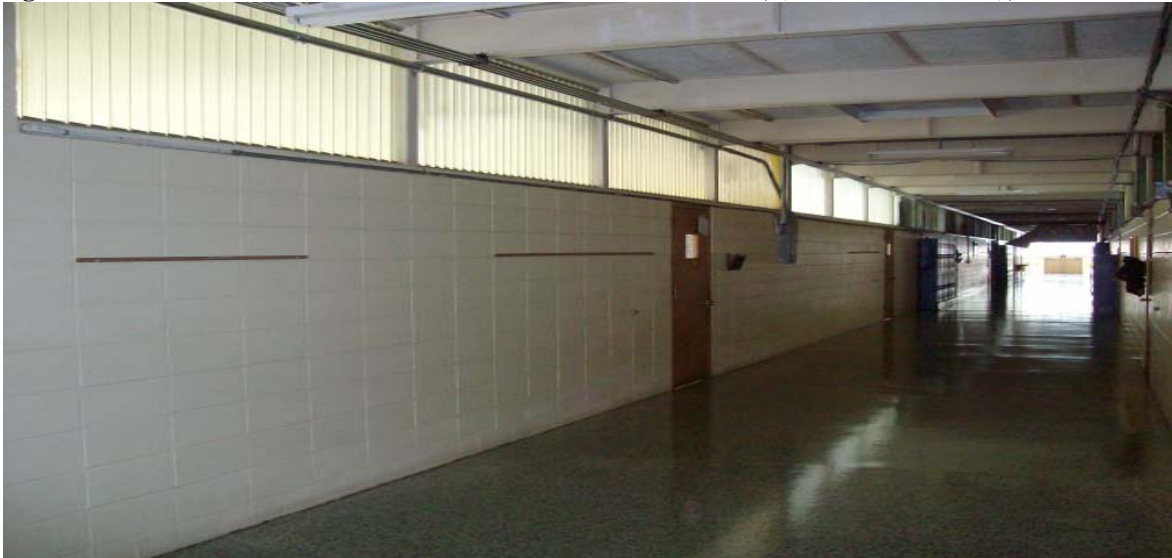
Figure 7: COMMON HALL WALL BETWEEN CLASSROOMS 12, (NEAREST DOOR), AND 11

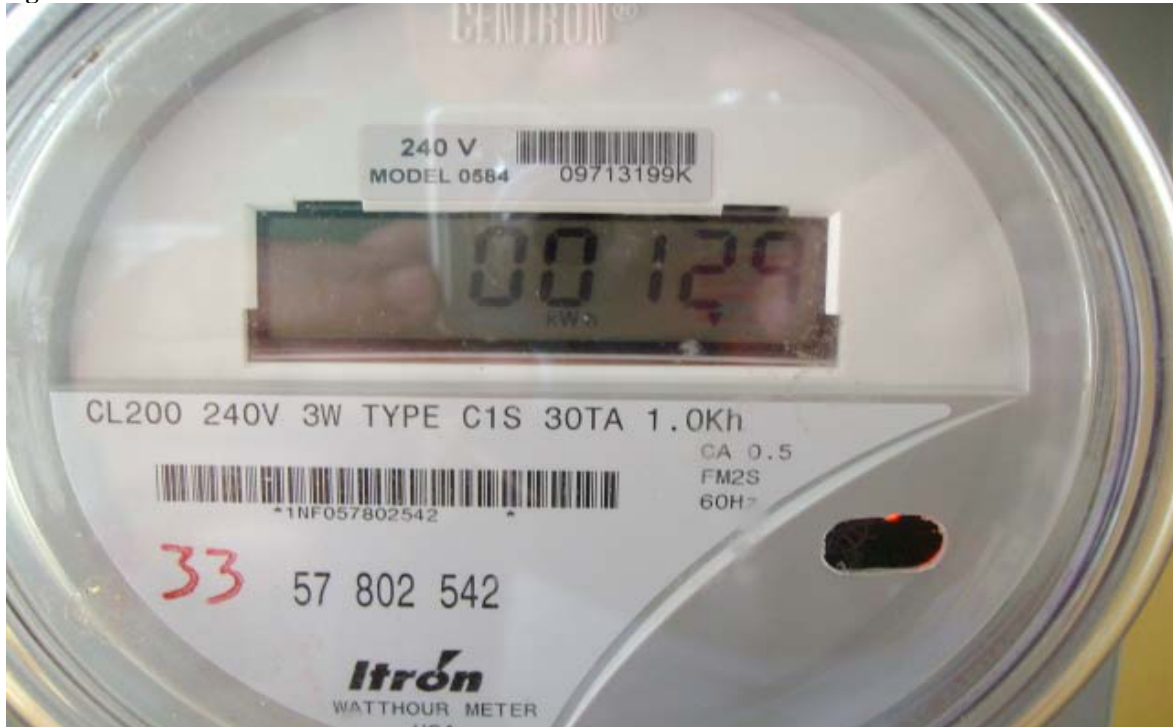
Figure 8: INITIAL READING UNCOATED ROOM 7/10/09 4:11 PM - 129 KWH

Meter readings were recorded on three separate occasions during onsite inspections; these are documented in the attached photos and their captions. Additionally, these meters have an automated reporting feature which provides continuous feedback to Southern Pine. Jeff Kirkland has forwarded a spreadsheet detailing daily usage of each meter and temperature as provided to them by NWS. Reduction of usage was slightly higher during first period than in the second, but marginally so. This could have been due to changes in outside ambient temperature and humidity. Interestingly, the power usage

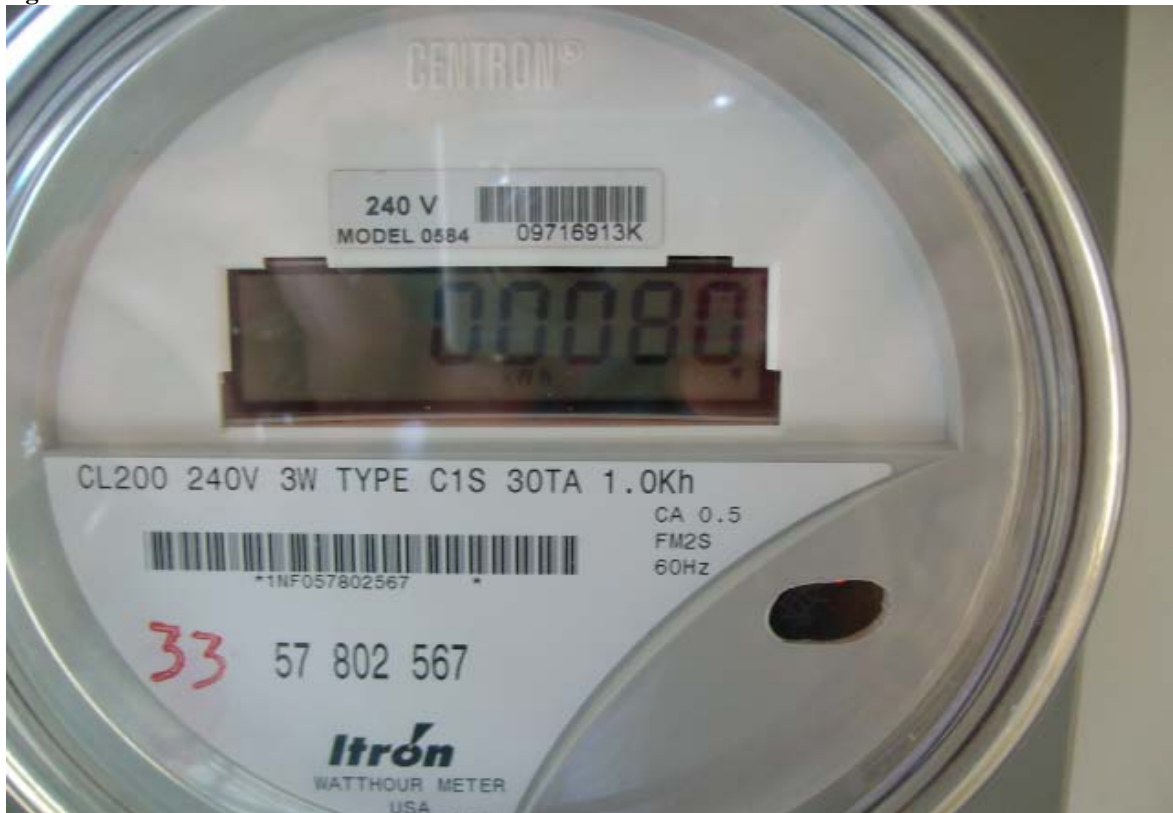
Figure 9: INITIAL READING COATED ROOM 7/10/09 4:13 PM - 80 KWH

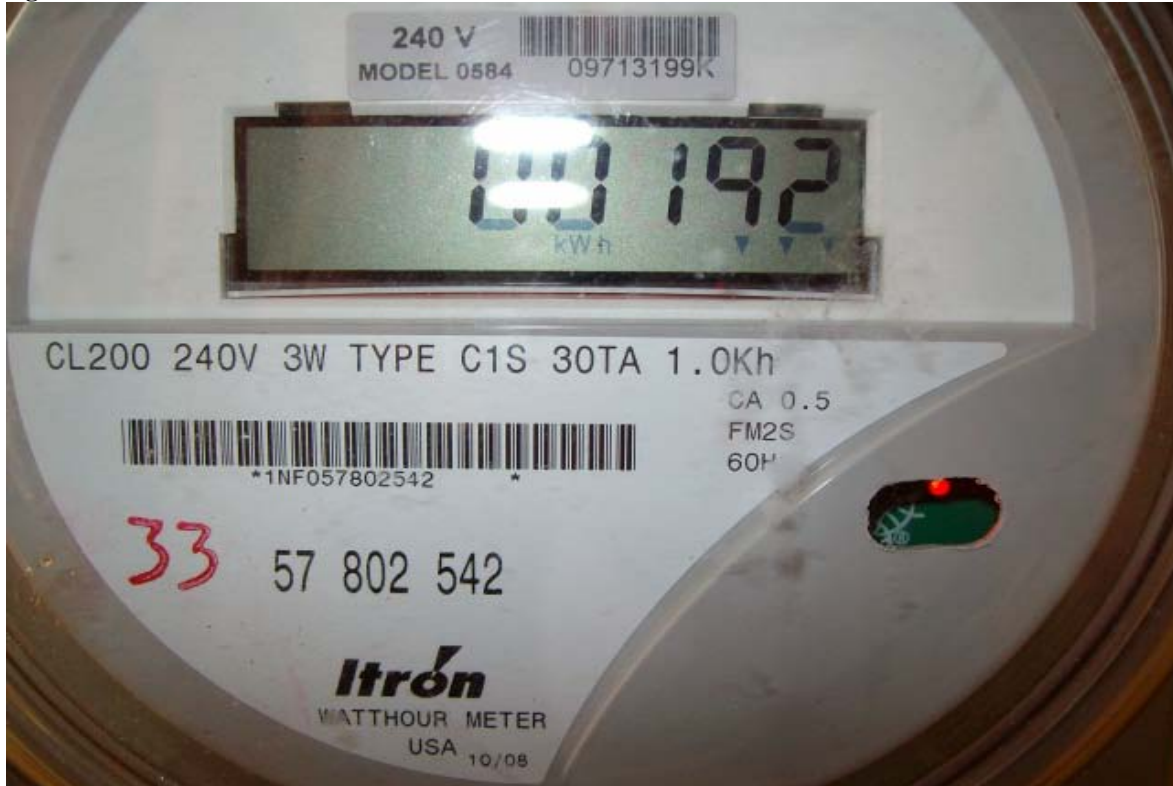
Figure 10: SECOND READING UNCOATED ROOM 7/13/09 2:58 PM – 192 KWH

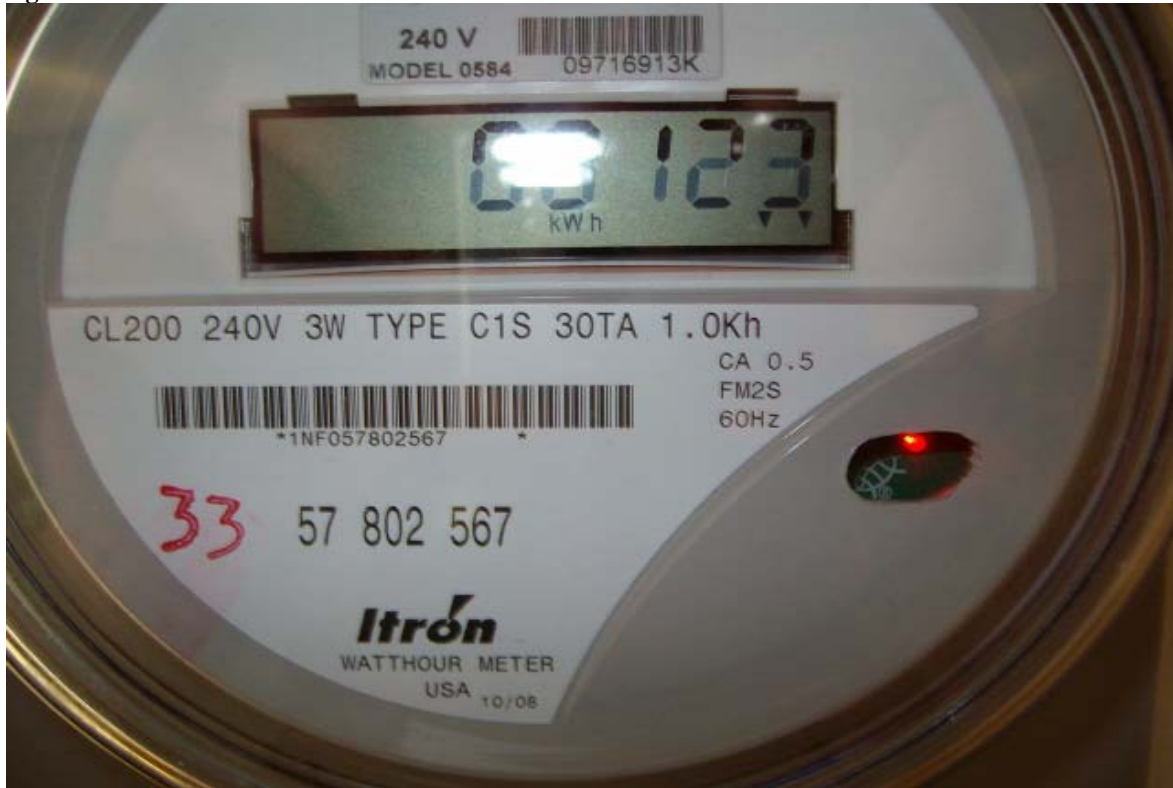
Figure 11: SECOND READING COATED ROOM 7/13/09 2:57 PM -123 KWHD

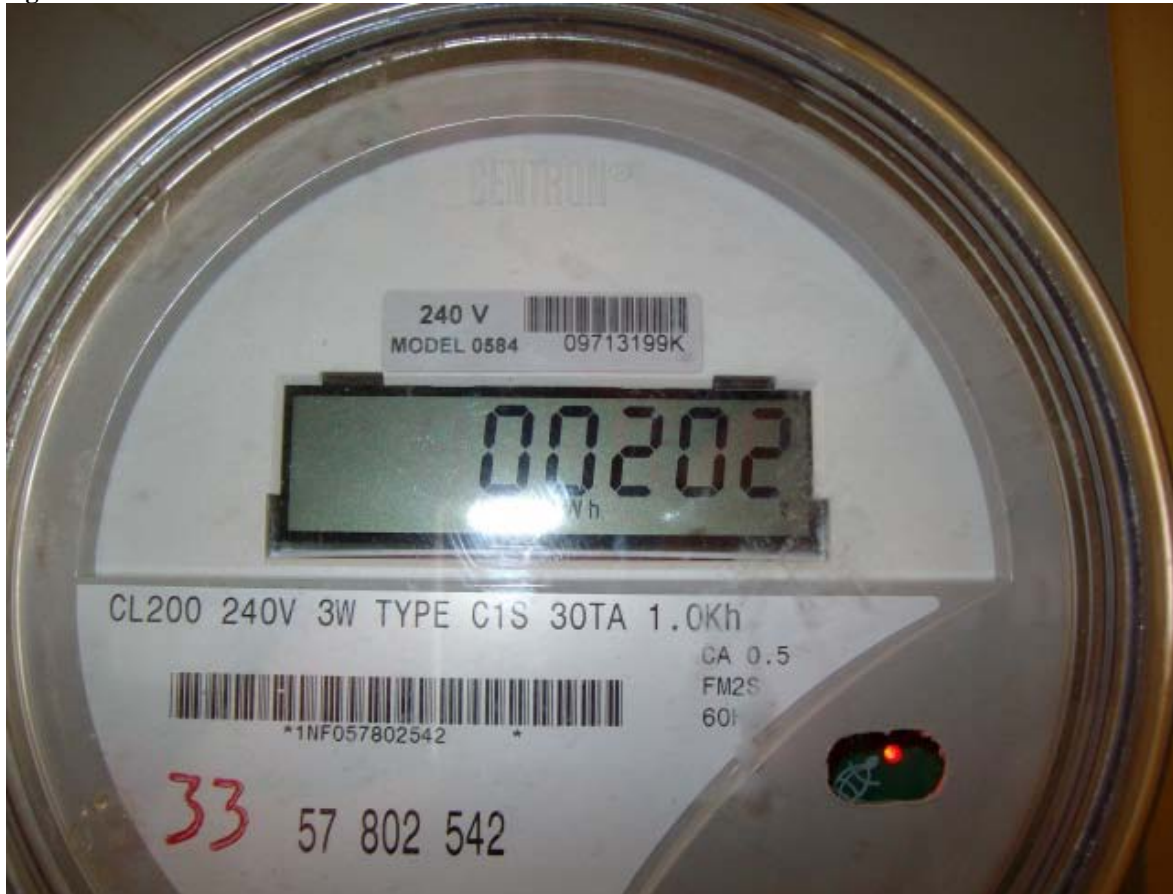
Figure 12: THIRD READING UNCOATED ROOM 7/14/09 12:13 PM 202 KWH

COATED ROOM	129 KWH
UNCOATED ROOM.....	202 KWH

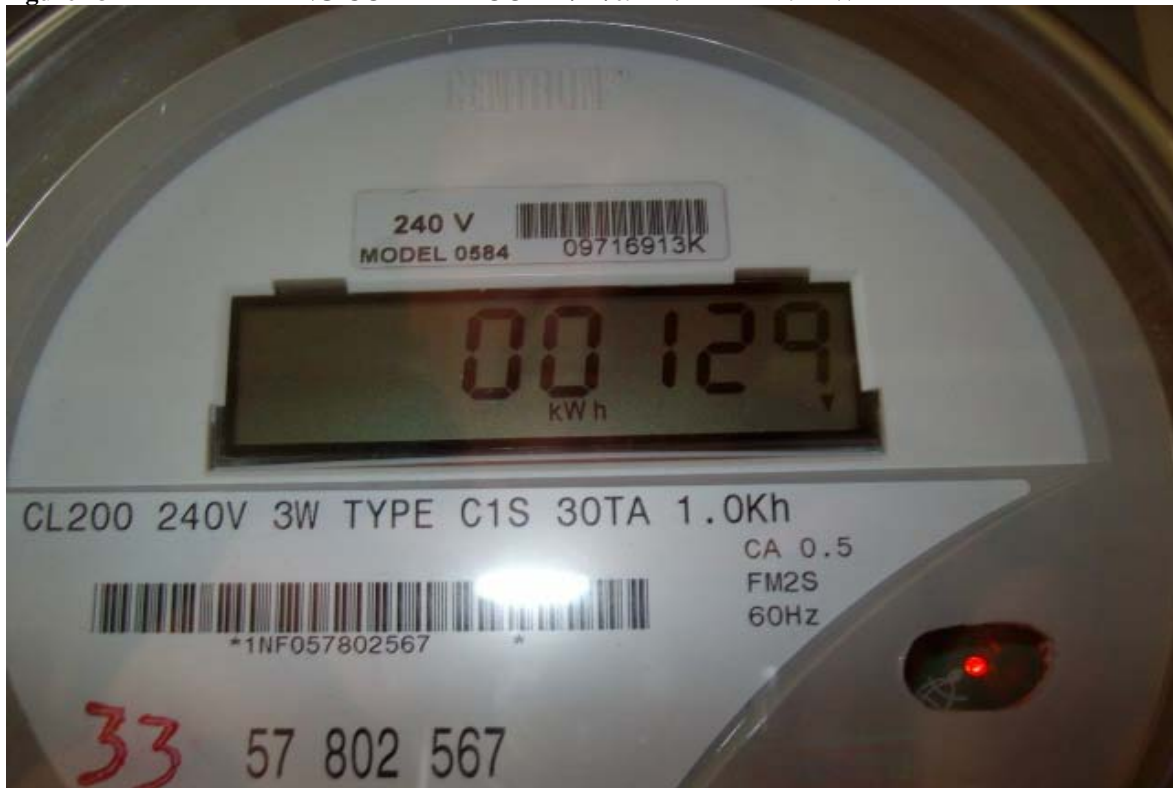
Figure 13 THIRD READING COATED ROOM 7/14/09 12:12 PM 129 KWH
