Crescent Real Estate Services Greenway Plaza Campus Houston, Texas

Subject: Report of performance of the 3800 building roof coating

Saturday August 21, 2010 Ambient O/A temp 95° F

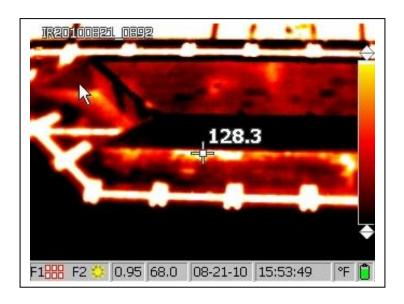
Bldg 8 – has cool roof material applied – the white areas in this picture are the brown sections of walk ways that are not coated with the cool roof material – they were 146⁰ F plus

This shows that the material applied reflects some energy but in itself heats up - where ThermaCote® does not elevate above ambient temperature
